**Flood Control Project Maintenance  
Levee Inspections**

**Maintenance Issue Types Only, Levee Inspection Report By Mile - Fall 2018**

**Reclamation District No. 0544 Upper Roberts Island**

Waterway	Bank	Unit Miles	Inspection Start/End	Inspector
Unit No. 01 San Joaquin River	Left	6.05	09/13/2018 09/13/2018	Richard Willoughby

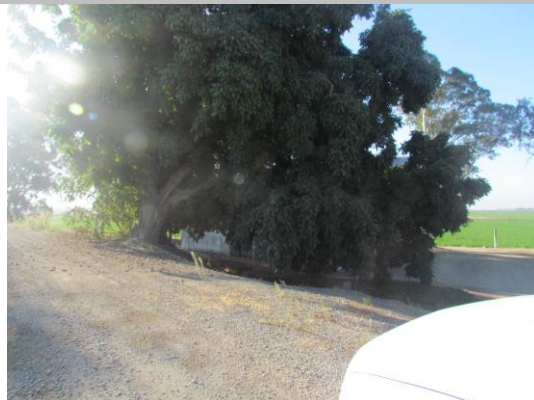
Photo 1 of 1 : FA\_2018\_RD0544\_108\_2\_20180906\_00002.jpg

LM Start	0.42	Rating **	M	Issue No.	2
LM End	0.42	Issue Type +	Ma	Location *	LS
Category	Earthen Levee			GPS Latitude/Longitude	
				Start	End
Item	Trim / Thin Trees			37.864958 °	37.864958 °
				-121.327142 °	-121.327142 °
DWR ID	DWR_RD0544_01_s_2012_2				
Comment Code					
T2 : Thin trees to allow visibility of the ground and room to flood fight.					
Inspector Comment					
Large untrimmed tree on landside slope.

Looking southwest at untrimmed tree on landward slope.

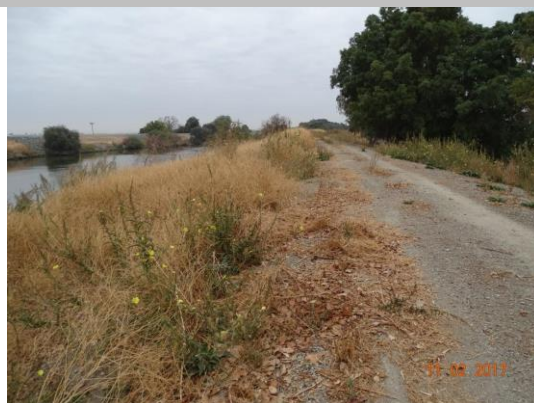
Photo 1 of 2 : FA\_2018\_RD0544\_108\_3\_20180906\_00003.jpg

LM Start	0.48	Rating **	U	Issue No.	3
LM End	0.67	Issue Type +	Ma	Location *	WS
Category	Earthen Levee			GPS Latitude/Longitude	
				Start	End
Item	Vegetation			37.864578 °	37.863753 °
				-121.326210 °	-121.322835 °
DWR ID	DWR_RD0544_01_s_2012_3				
Comment Code					
V2 : Remove the wild growth other than native grasses from the levee slopes.					
Inspector Comment					
Dense vegetation on waterside and landside slopes.

Looking southeast at the waterside slope.

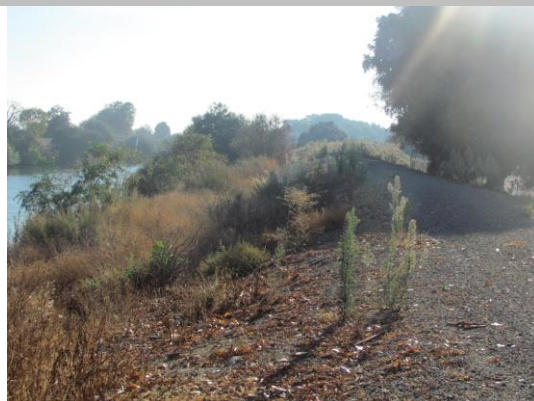
Photo 2 of 2 : FA\_2018\_RD0544\_108\_3\_20180906\_00004.jpg

Looking south at dense veg on waterward slope.

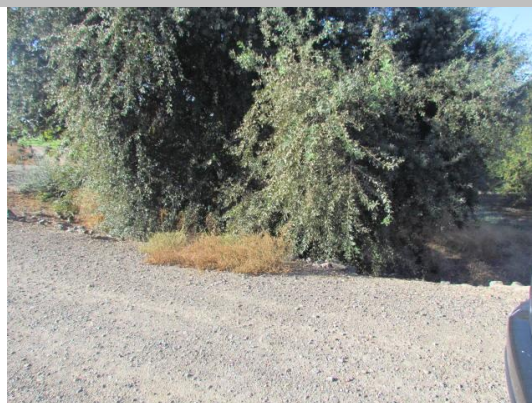
Photo 1 of 1 : FA\_2018\_RD0544\_108\_93\_20180906\_00067.jpg

LM Start	0.81	Rating **	M	Issue No.	93
LM End	0.81	Issue Type +	Ma	Location *	LS
Category	Earthen Levee			GPS Latitude/Longitude	
				Start	End
Item	Trim / Thin Trees			37.862694°	37.862694°
				-121.320887°	-121.320887°
DWR ID	DWR_RD0544_01_f_2014_93				
Comment Code					
T1 : Trim trees to at least five feet above ground level.					
Inspector Comment

Looking west at untrimmed trees on landward slope and toe fall 2015.

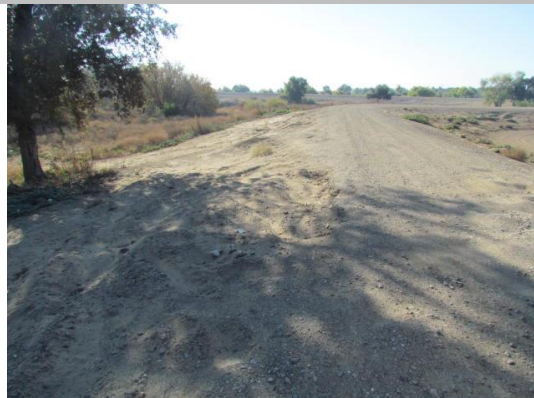
Photo 1 of 3 : FA\_2018\_RD0544\_108\_119\_20180906\_00085.jpg

LM Start	1.50	Rating **	M	Issue No.	119
LM End	1.51	Issue Type +	Ma	Location *	WS
Category	Earthen Levee			GPS Latitude/Longitude	
				Start	End
Item	Slope Stability			37.854844 °	37.854564 °
				-121.321090 °	-121.321031 °
DWR ID	DWR_RD0544_01_f_2015_119				
Comment Code					
S2 : Repair the levee slope damaged by foot traffic and prevent access where possible.					
Inspector Comment					
Damaged levee slope due to fishermen using slope as a ramp.

Looking southeast at damaged waterward slope fall 2015.

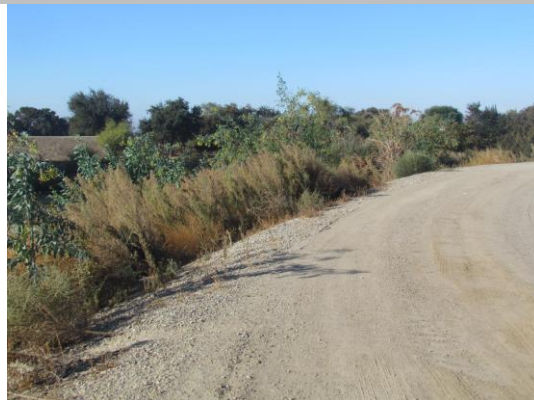
Photo 1 of 1 : FA\_2018\_RD0544\_108\_43\_20180906\_00034.jpg

LM Start	1.56	Rating **	U	Issue No.	43
LM End	1.76	Issue Type +	Ma	Location *	WS
Category	Earthen Levee			GPS Latitude/Longitude	
				Start	End
Item	Vegetation			37.854068 °	37.853980 °
				-121.321387 °	-121.324213 °
DWR ID	DWR_RD0544_01_s_2012_43				
Comment Code					
V2 : Remove the wild growth other than native grasses from the levee slopes.					
Inspector Comment					
Dense vegetation waterside slope.

Looking east at dense veg on waterward slope.

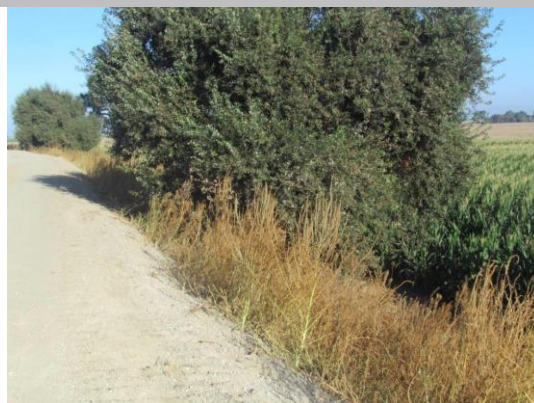
Photo 1 of 1 : FA\_2018\_RD0544\_108\_95\_20180906\_00068.jpg

LM Start	1.59	Rating **	M	Issue No.	95
LM End	1.59	Issue Type +	Ma	Location *	LS
Category	Earthen Levee			GPS Latitude/Longitude	
				Start	End
Item	Trim / Thin Trees			37.854299 °	37.854299 °
				-121.321865 °	-121.321865 °
DWR ID	DWR_RD0544_01_s_2018_95				
Comment Code					
T1 : Trim trees to at least five feet above ground level.					
Inspector Comment					
Untrimmed tree on landside slope.

Looking southwest at untrimmed tree on landward slope.

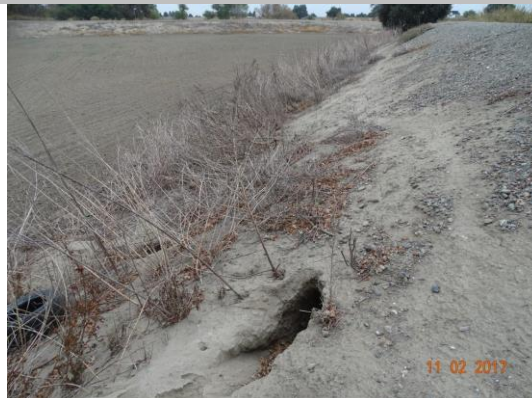
Photo 1 of 1 : FA\_2018\_RD0544\_108\_146\_20180906\_00129.jpg

LM Start	1.63	Rating **	U	Issue No.	146
LM End	1.63	Issue Type +	Ma	Location *	LS
Category	Earthen Levee			GPS Latitude/Longitude	
				Start	End
Item	Animal Control			37.854643 °	37.854643 °
				-121.322429 °	-121.322429 °
DWR ID	DWR_RD0544_01_f_2017_146				
Comment Code					
A3 : No rodents visible, but rodent burrows visible; need to backfill and compact or grout burrows.					
Inspector Comment					
Large rodent hole on landside slope.

Looking east at the landside slope.

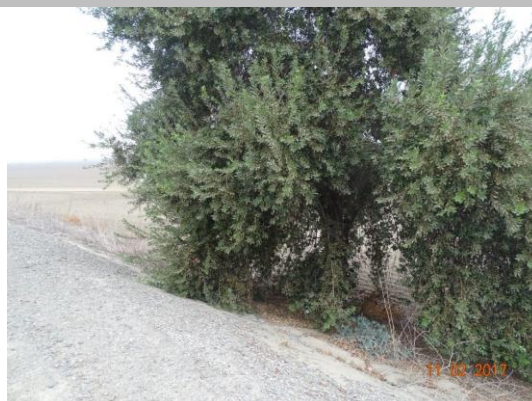
Photo 1 of 1 : FA\_2018\_RD0544\_108\_145\_20180906\_00128.jpg

LM Start	1.64	Rating **	M	Issue No.	145
LM End	1.64	Issue Type +	Ma	Location *	LS
Category	Earthen Levee			GPS Latitude/Longitude	
				Start	End
Item	Trim / Thin Trees			37.854673 °	37.854673 °
				-121.322492 °	-121.322492 °
DWR ID	DWR_RD0544_01_f_2017_145				
Comment Code					
T1 : Trim trees to at least five feet above ground level.					
Inspector Comment

Looking northwest at the landside slope.

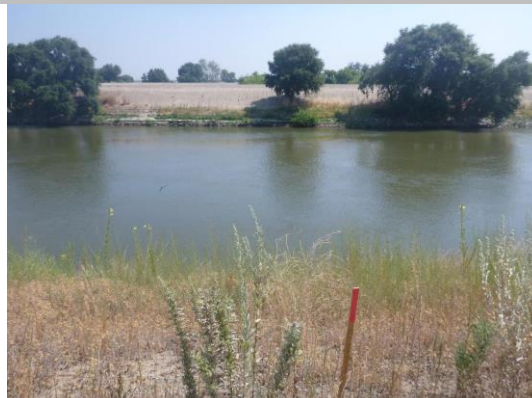
Photo 1 of 3 : LEVAL\_FA\_2018\_569\_4614.jpg

LM Start	1.89	Rating **	A/W	Issue No.	127
LM End	1.91	Issue Type +	Ma	Location *	
Category	Supplemental			GPS Latitude/Longitude	
				Start	End
Item	2017 Storm Damage			37.852300°	37.852000°
				-121.323700°	-121.323600°
DWR ID	DWR_RD0544_01_f_2017_127				
Comment Code

Description: Slope protection repairs are needed along the waterside slope due to erosion and riprap displacement from high water. Based upon levee inspections, it was determined the waterside levee slope is eroding, deteriorating, and degrading. The eroded levee sections need to be restored back to design standards to prevent further deterioration and damage.

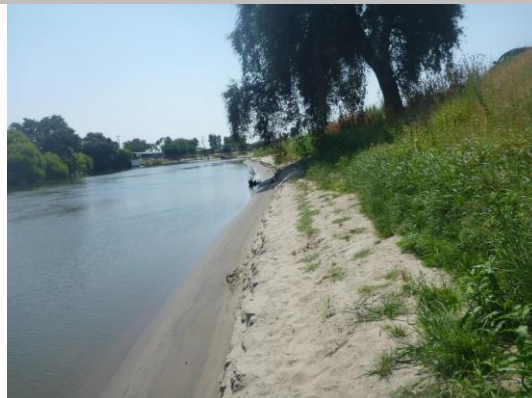
Photo 3 of 3 : LEVAL\_FA\_2018\_569\_4616.jpg

LM Start	1.89	Rating **	A/W	Issue No.	127 (cont)
LM End	1.91	Issue Type +	Ma	Location *	
Category	Supplemental			GPS Latitude/Longitude	
				Start	End
Item	2017 Storm Damage			37.852300 °	37.852000 °
				-121.323700 °	-121.323600 °
DWR ID	DWR_RD0544_01_f_2017_127				
Comment Code					
Inspector Comment					
Levee Evaluation Comments					
Description:Slope protection repairs are needed along the waterside slope due to erosion and riprap displacement from high water. Based upon levee inspections, it was determined the waterside levee slope is eroding, deteriorating, and degrading. The eroded levee sections need to be restored back to design standards to prevent further deterioration and damage.					
Site ID No:569					
Site Designation:LMA-475					
Repair Type: Erosion					
Rating:Area of Concern					
Field Date:8/10/2017					
Notes:

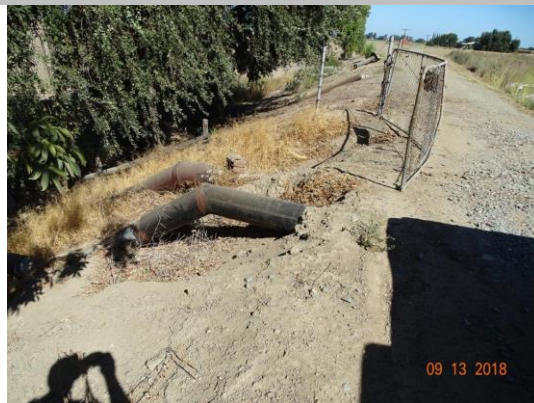
Photo 2 of 3 : FA\_2018\_RD0544\_108\_44\_20180919\_00174.jpg

LM Start	2.27	Rating **	U	Issue No.	44
LM End	2.27	Issue Type +	Ma	Location *	LS
Category	Earthen Levee			GPS Latitude/Longitude	
				Start	End
Item	Erosion / Bank Caving			37.847990 °	37.847990 °
				-121.324897 °	-121.324897 °
DWR ID	DWR_RD0544_01_f_2018_44				
Comment Code					
E2 : Schedule repair of erosion site prior to the next inspection.					
Inspector Comment					
erosion around irrigation pipe on landward slope.

Looking northwest at erosion around irrigation pipe on landward slope.  
(Fall 2018)**\* Location**

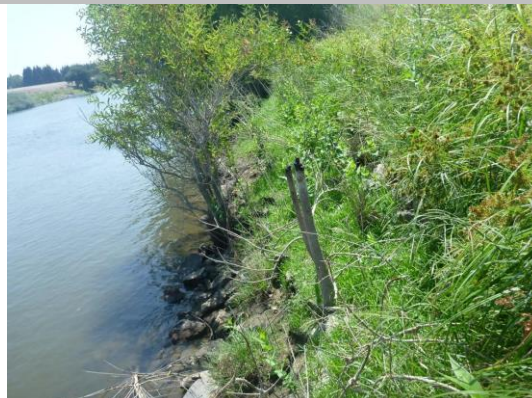
Photo 2 of 3 : LEVAL\_FA\_2018\_568\_4545.jpg

LM Start	2.31	Rating **	A/W	Issue No.	128 (cont)
LM End	2.35	Issue Type +	Ma	Location *	
Category	Supplemental			GPS Latitude/Longitude	
				Start	End
Item	2017 Storm Damage			37.847300 °	37.846800 °
				-121.324700 °	-121.324400 °
DWR ID	DWR_RD0544_01_f_2017_128

Description: Slope protection repairs are needed along the waterside slope due to erosion and riprap displacement from high water. Based upon levee inspections, it was determined the waterside levee slope is eroding, deteriorating, and degrading. The eroded levee sections need to be restored back to design standards to prevent further deterioration and damage.

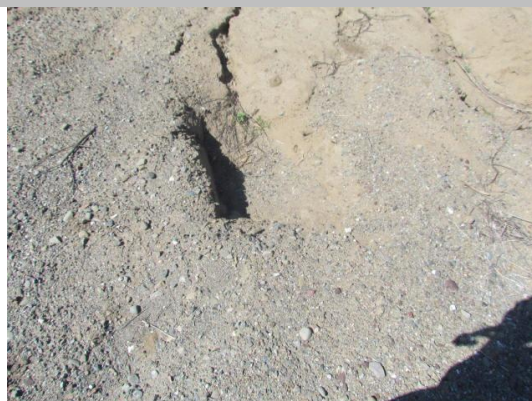
Photo 1 of 2 : FA\_2018\_RD0544\_108\_107\_20180906\_00074.jpg

LM Start	2.95	Rating **	M	Issue No.	107
LM End	2.96	Issue Type +	Ma	Location *	LS
Category	Earthen Levee			GPS Latitude/Longitude	
				Start	End
Item	Erosion / Bank Caving			37.840560 °	37.840467 °
				-121.318463 °	-121.318367 °
DWR ID	DWR_RD0544_01_s_2015_107				
Comment Code					
E1 : Note and monitor erosion site.					
Inspector Comment					
Several depressions on landside slope within this reach.

Looking south at depression on landward slope.

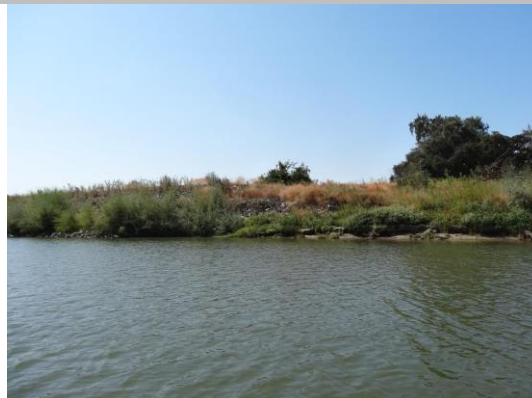
Photo 1 of 3 : FA\_2018\_RD0544\_108\_5\_20180906\_00010.jpg

LM Start	2.95	Rating **	M	Issue No.	5
LM End	2.95	Issue Type +	Ma	Location *	WS
Category	Supplemental			GPS Latitude/Longitude	
				Start	End
Item	DWR Erosion Survey			37.840697 °	37.840697 °
				-121.318252 °	-121.318252 °
DWR ID	RD0544U01RM49.67				
Comment Code					
Inspector Comment					
09/13/2017: No significant change observed.					
07/25/2016: No significant change observed.					
06/24/2015: No significant change observed.					
06/19/2014: No significant change observed.					
08/13/2013: Pump has been removed. A larger pocket erosion has been found at the erosion site.					
08/07/2012: The erosion is immediately upstream of a river bend.					
Dense vegetation is visible at the erosion site. [2017 Site ID:RD0544U01RM49.67]

Front view of the erosion.

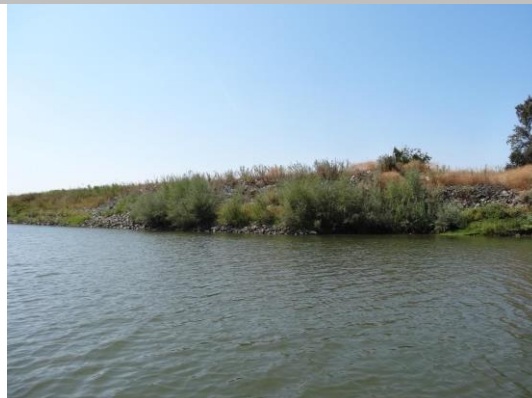
Photo 3 of 3 : FA\_2018\_RD0544\_108\_5\_20180906\_00012.jpg

LM Start	2.95	Rating **	M	Issue No.	5 (cont)	
LM End	2.95	Issue Type +	Ma	Location *	WS	
Category	Supplemental			GPS Latitude/Longitude		
				Start		End
Item	DWR Erosion Survey			37.840697 °		37.840697 °
				-121.318252 °		-121.318252 °
DWR ID	RD0544U01RM49.67					
Comment Code						
Inspector Comment						
09/13/2017: No significant change observed.						
07/25/2016: No significant change observed.						
06/24/2015: No significant change observed.						
06/19/2014: No significant change observed.						
08/13/2013: Pump has been removed. A larger pocket erosion has been found at the erosion site.						
08/07/2012: The erosion is immediately upstream of a river bend.						
Dense vegetation is visible at the erosion site. [2017 Site ID:RD0544U01RM49.67]

Downstream view of the site.

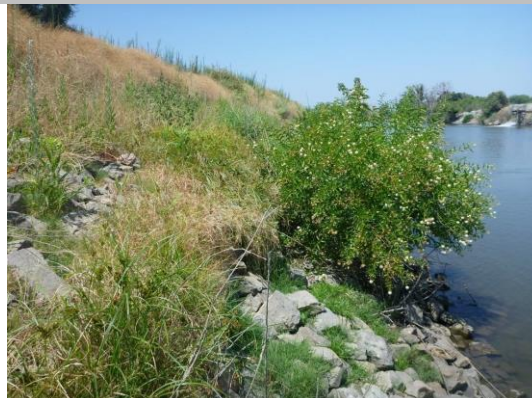
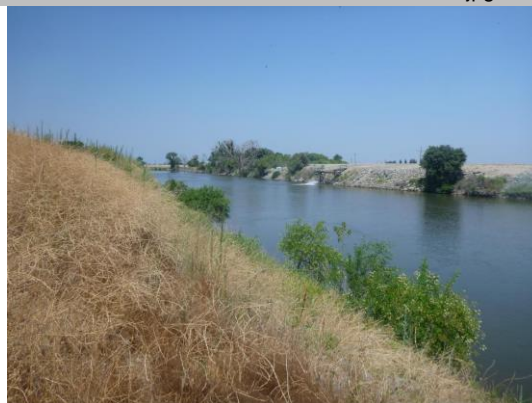
LM Start	3.21	Rating **	A/W	Issue No.	131 (cont)	
LM End	3.22	Issue Type +	Ma	Location *		
Category	Supplemental			GPS Latitude/Longitude		
				Start	End	
Item	2017 Storm Damage			37.836900 °	37.836700 °	
				-121.317300 °	-121.317300 °	
DWR ID	DWR_RD0544_01_f_2017_131					
Comment Code						
Inspector Comment						
Levee Evaluation Comments						
Description:Slope protection repairs are needed along the waterside slope due to erosion and riprap displacement from high water. Based upon levee inspections, it was determined the waterside levee slope is eroding, deteriorating, and degrading. The eroded levee sections need to be restored back to design standards to prevent further deterioration and damage.						
Site ID No:566						
Site Designation:LMA-472						
Repair Type: Erosion						
Rating:Area of Concern						
Field Date:8/10/2017						
Notes:

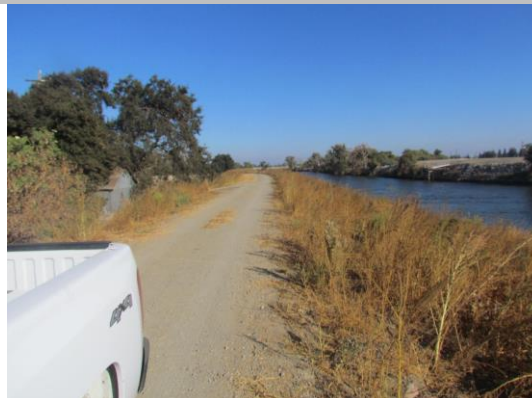
Photo 1 of 1 : FA\_2018\_RD0544\_108\_49\_20180906\_00038.jpg

LM Start	3.22	Rating **	U	Issue No.	49
LM End	3.84	Issue Type +	Ma	Location *	WS
Category	Earthen Levee			GPS Latitude/Longitude	
				Start	End
Item	Vegetation			37.836763 °	37.829195 °
				-121.317307 °	-121.311918 °
DWR ID	DWR_RD0544_01_s_2012_49				
Comment Code					
V2 : Remove the wild growth other than native grasses from the levee slopes.					
Inspector Comment					
Dense vegetation on waterside slope.

Looking northeast at dense veg on waterward slope.

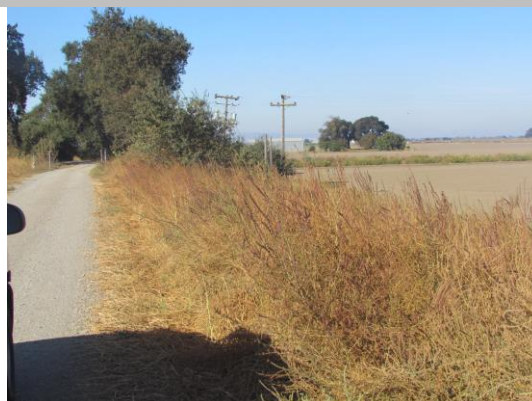
Photo 1 of 1 : FA\_2018\_RD0544\_108\_48\_20180906\_00037.jpg

LM Start	3.23	Rating **	U	Issue No.	48
LM End	3.26	Issue Type +	Ma	Location *	LS
Category	Earthen Levee			GPS Latitude/Longitude	
				Start	End
Item	Vegetation			37.836615 °	37.836133 °
				-121.317285 °	-121.317153 °
DWR ID	DWR_RD0544_01_s_2012_48				
Comment Code					
V2 : Remove the wild growth other than native grasses from the levee slopes.					
Inspector Comment

Looking south at typical view of dense veg on landward slope.

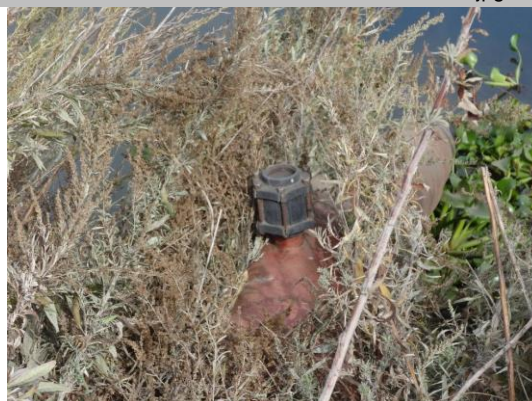
Photo 1 of 3 : UCIP\_FA\_2018\_24892\_44853.jpg

WS view: exposed steel pipe on bank of the channel.

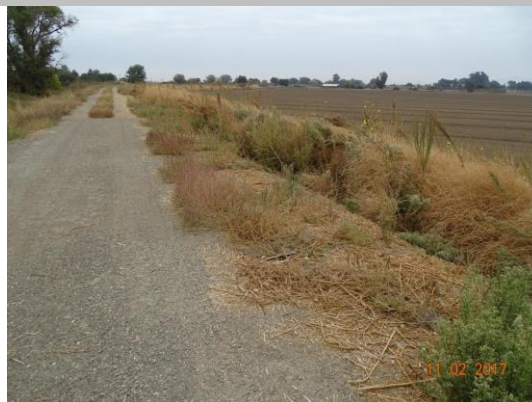
Photo 1 of 1 : FA\_2018\_RD0544\_108\_51\_20180906\_00039.jpg

LM Start	3.49	Rating **	U	Issue No.	51
LM End	4.67	Issue Type +	Ma	Location *	LS
Category	Earthen Levee			GPS Latitude/Longitude	
				Start	End
Item	Vegetation			37.833432 °	37.821853 °
				-121.314792 °	-121.319992 °
DWR ID	DWR_RD0544_01_s_2012_51				
Comment Code					
V2 : Remove the wild growth other than native grasses from the levee slopes.					
Inspector Comment

Looking southeast at the landside slope.

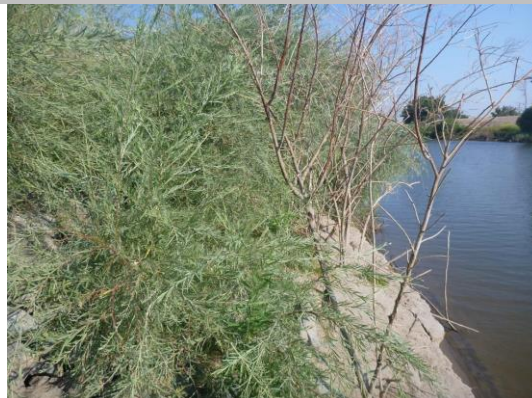
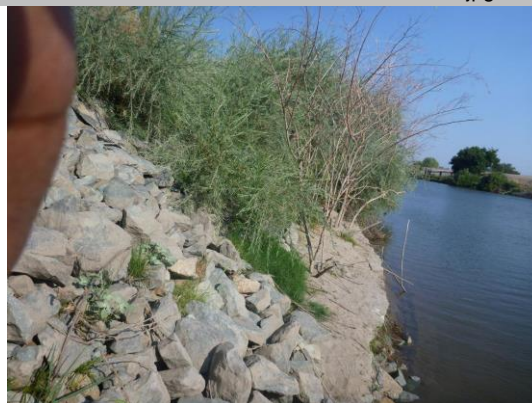
LM Start	3.65	Rating **	A/W	Issue No.	132
LM End	3.67	Issue Type +	Ma	Location *	
Category	Supplemental			GPS Latitude/Longitude	
				Start	End
Item	2017 Storm Damage			37.831800 °	37.831600 °
				-121.312700 °	-121.312600 °
DWR ID	DWR_RD0544_01_f_2017_132				
Comment Code					
Inspector Comment					
Levee Evaluation Comments					
Description:Slope protection repairs are needed along the waterside slope due to erosion and riprap displacement from high water. Based upon levee inspections, it was determined the waterside levee slope is eroding, deteriorating, and degrading. The eroded levee sections need to be restored back to design standards to prevent further deterioration and damage.					
Site ID No:565					
Site Designation:LMA-471					
Repair Type: Erosion					
Rating:Area of Concern					
Field Date:8/11/2017					
Notes: dense shrubs on levee slope

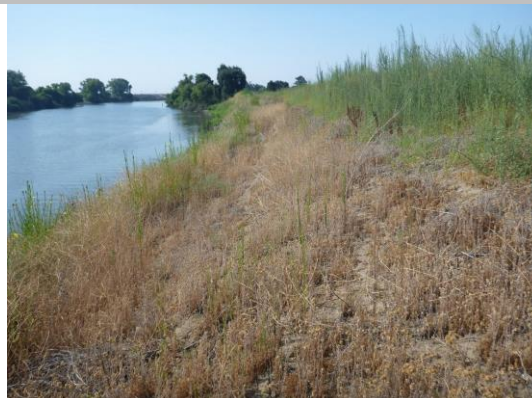
Photo 2 of 3 : LEVAL\_FA\_2018\_564\_4750.jpg

LM Start	3.69	Rating **	A/W	Issue No.	133 (cont)	
LM End	3.73	Issue Type +	Ma	Location *		
Category	Supplemental			GPS Latitude/Longitude		
				Start	End	
Item	2017 Storm Damage			37.831300 °	37.830700 °	
				-121.312600 °	-121.312300 °	
DWR ID	DWR_RD0544_01_f _ 2017_133					
Comment Code						
Inspector Comment						
Levee Evaluation Comments						
Description:Slope protection repairs are needed along the waterside slope due to erosion and riprap displacement from high water. Based upon levee inspections, it was determined the waterside levee slope is eroding, deteriorating, and degrading. The eroded levee sections need to be restored back to design standards to prevent further deterioration and damage.						
Site ID No:564						
Site Designation:LMA-470						
Repair Type: Erosion						
Rating:Area of Concern						
Field Date:8/11/2017						
Notes: big rodent holes on levee slopes

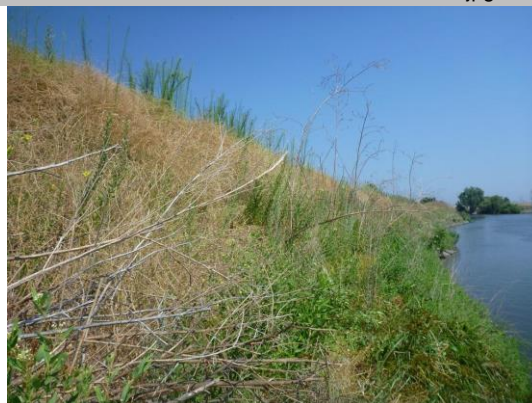
Photo 2 of 3 : LEVAL\_FA\_2018\_562\_4835.jpg

LM Start	3.81	Rating **	A/W	Issue No.	135
LM End	3.82	Issue Type +	Ma	Location *	
Category	Supplemental			GPS Latitude/Longitude	
				Start	End
Item	2017 Storm Damage			37.829600 °	37.829400 °
				-121.312000 °	-121.312000 °
DWR ID	DWR_RD0544_01_f_2017_135				
Comment Code					
Inspector Comment					
Levee Evaluation Comments					
Description:Slope protection repairs are needed along the waterside slope due to erosion and riprap displacement from high water. Based upon levee inspections, it was determined the waterside levee slope is eroding, deteriorating, and degrading. The eroded levee sections need to be restored back to design standards to prevent further deterioration and damage.					
Site ID No:562					
Site Designation:LMA-468					
Repair Type: Erosion					
Rating:Serious					
Field Date:8/11/2017					
Notes: Site combined with LMA-469;

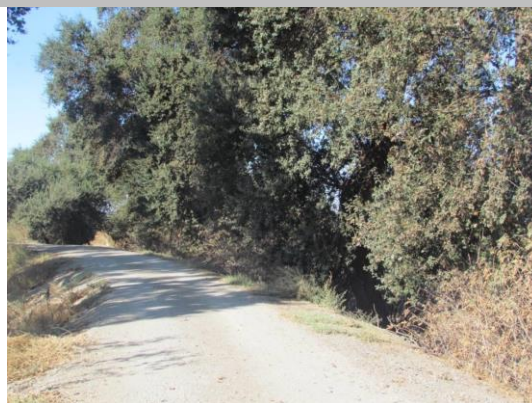
Photo 1 of 1 : FA\_2018\_RD0544\_108\_120\_20180906\_00088.jpg

LM Start	4.25	Rating **	U	Issue No.	120
LM End	4.28	Issue Type +	Ma	Location *	LS
Category	Earthen Levee			GPS Latitude/Longitude	
				Start	End
Item	Trim / Thin Trees			37.825482 °	37.825229 °
				-121.314298 °	-121.314771 °
DWR ID	DWR_RD0544_01_f_2015_120				
Comment Code					
T1 : Trim trees to at least five feet above ground level.					
Inspector Comment					
Several untrimmed trees on landside slope.

Looking southwest at untrimmed trees on landward slope.

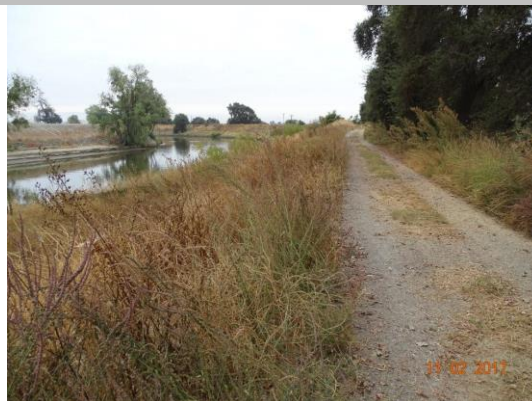
Photo 1 of 2 : FA\_2018\_RD0544\_108\_117\_20180906\_00082.jpg

LM Start	4.41	Rating **	U	Issue No.	117
LM End	4.79	Issue Type +	Ma	Location *	WS
Category	Earthen Levee			GPS Latitude/Longitude	
				Start	End
Item	Vegetation			37.823522 °	37.820557 °
				-121.315735 °	-121.321217 °
DWR ID	DWR_RD0544_01_s_2017_117				
Comment Code					
V2 : Remove the wild growth other than native grasses from the levee slopes.					
Inspector Comment

Looking southwest at the waterside slope.

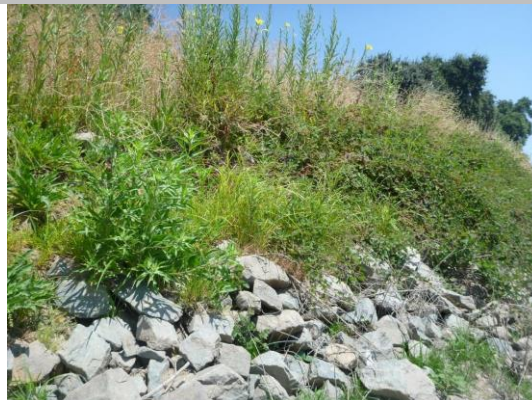
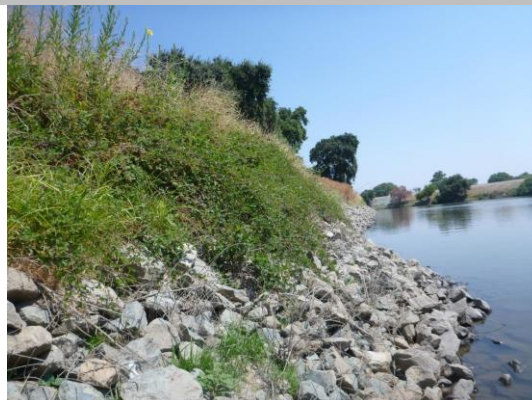
LM Start	4.46	Rating **	A/W	Issue No.	136 (cont)
LM End	4.48	Issue Type +	Ma	Location *	
Category	Supplemental			GPS Latitude/Longitude	
				Start	End
Item	2017 Storm Damage			37.823200 °	37.823000 °
				-121.316400 °	-121.316800 °
DWR ID	DWR_RD0544_01_f_2017_136

Comment Code					
Inspector Comment					
Levee Evaluation Comments					
Description:Slope protection repairs are needed along the waterside slope due to erosion and riprap displacement from high water. Based upon levee inspections, it was determined the waterside levee slope is eroding, deteriorating, and degrading. The eroded levee sections need to be restored back to design standards to prevent further deterioration and damage.					
Site ID No:561					
Site Designation:LMA-467					
Repair Type: Erosion					
Rating:Area of Concern					
Field Date:8/11/2017					
Notes: site combined with LMA-466 in field; length and coordinates redefined in field.

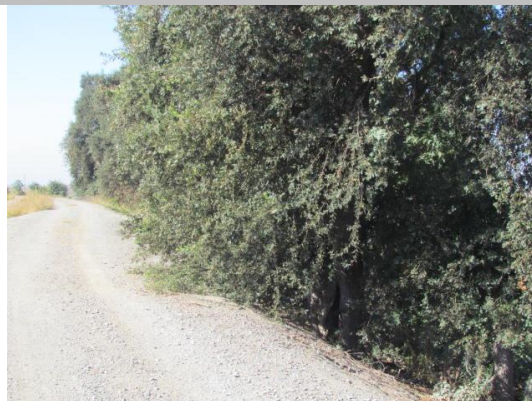
Photo 1 of 1 : FA\_2018\_RD0544\_108\_104\_20180906\_00071.jpg

LM Start	4.64	Rating **	U	Issue No.	104
LM End	4.68	Issue Type +	Ma	Location *	LS
Category	Earthen Levee			GPS Latitude/Longitude	
				Start	End
Item	Trim / Thin Trees			37.822033 °	37.821826 °
				-121.319432 °	-121.320071 °
DWR ID	DWR_RD0544_01_f_2014_104				
Comment Code					
T2 : Thin trees to allow visibility of the ground and room to flood fight.					
Inspector Comment					
Dense untrimmed trees on landside slope.

Looking southwest at dense untrimmed trees on landward slope fall 2015.

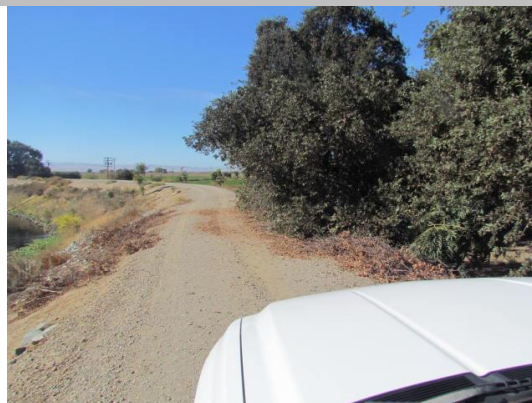
Photo 1 of 1 : FA\_2018\_RD0544\_108\_105\_20180906\_00072.jpg

LM Start	4.69	Rating **	U	Issue No.	105
LM End	4.69	Issue Type +	Ma	Location *	LS
Category	Earthen Levee			GPS Latitude/Longitude	
				Start	End
Item	Trim / Thin Trees			37.821775 °	37.821775 °
				-121.320203 °	-121.320203 °
DWR ID	DWR_RD0544_01_f_2014_105				
Comment Code					
T2 : Thin trees to allow visibility of the ground and room to flood fight.					
Inspector Comment					
Tree has overgrown onto levee crown.

Looking south at overgrown tree on landward shoulder.

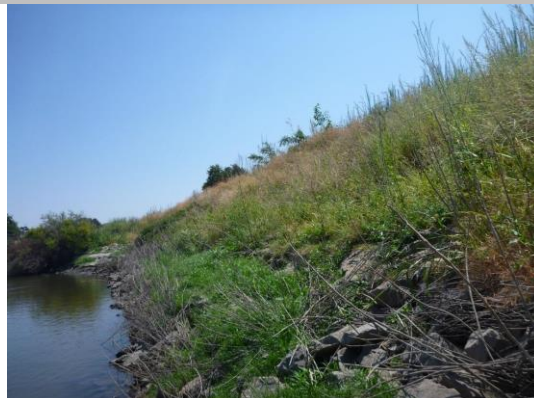
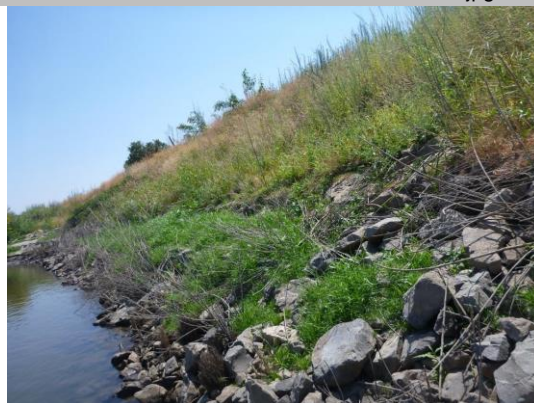
LM Start	4.97	Rating **	A/W	Issue No.	139 (cont)	
LM End	4.99	Issue Type +	Ma	Location *		
Category	Supplemental			GPS Latitude/Longitude		
				Start		End
Item	2017 Storm Damage			37.818600 °		37.818400 °
				-121.319200 °		-121.319000 °
DWR ID	DWR_RD0544_01_f_2017_139					
Comment Code						
Inspector Comment						
Levee Evaluation Comments						
Description:Slope protection repairs are needed along the waterside slope due to erosion and riprap displacement from high water. Based upon levee inspections, it was determined the waterside levee slope is eroding, deteriorating, and degrading. The eroded levee sections need to be restored back to design standards to prevent further deterioration and damage.						
Site ID No:559						
Site Designation:LMA-465						
Repair Type: Erosion						
Rating:Serious						
Field Date:8/11/2017						
Notes:

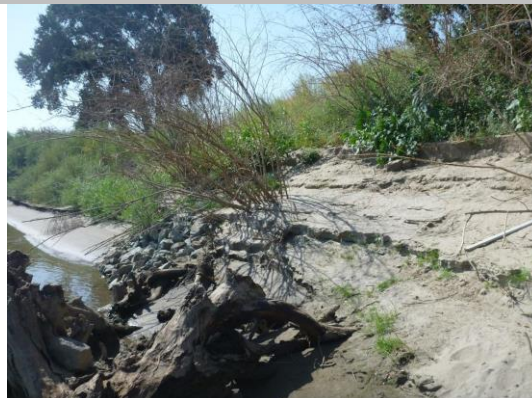
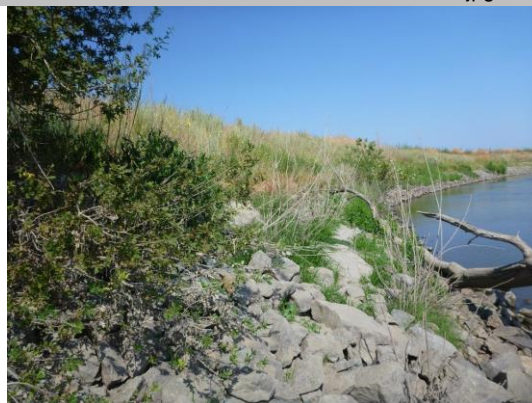
LM Start	5.32	Rating **	A/W	Issue No.	140
LM End	5.36	Issue Type +	Ma	Location *	
Category	Supplemental			GPS Latitude/Longitude	
				Start	End
Item	2017 Storm Damage			37.813900 °	37.813500 °
				-121.319900 °	-121.319400 °
DWR ID	DWR_RD0544_01_f_2017_140				
Comment Code					
Inspector Comment					
Levee Evaluation Comments					
Description:Slope protection repairs are needed along the waterside slope due to erosion and riprap displacement from high water. Based upon levee inspections, it was determined the waterside levee slope is eroding, deteriorating, and degrading. The eroded levee sections need to be restored back to design standards to prevent further deterioration and damage.					
Site ID No:558					
Site Designation:LMA-464					
Repair Type: Erosion					
Rating:Serious					
Field Date:8/16/2017					
Notes:

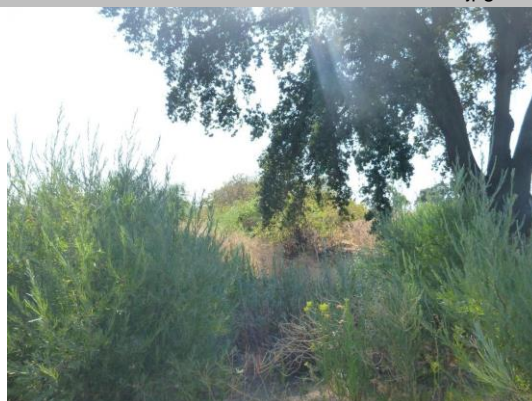
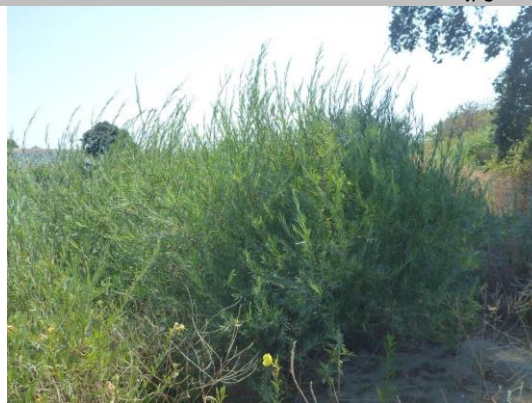
LM Start	5.36	Rating **	A/W	Issue No.	141 (cont)	
LM End	5.37	Issue Type +	Ma	Location *		
Category	Supplemental			GPS Latitude/Longitude		
				Start	End	
Item	2017 Storm Damage			37.813400 °	37.813300 °	
				-121.319300 °	-121.319200 °	
DWR ID	DWR_RD0544_01_f_2017_141					
Comment Code						
Inspector Comment						
Levee Evaluation Comments						
Description:Slope protection repairs are needed along the waterside slope due to erosion and riprap displacement from high water. Based upon levee inspections, it was determined the waterside levee slope is eroding, deteriorating, and degrading. The eroded levee sections need to be restored back to design standards to prevent further deterioration and damage.						
Site ID No:557						
Site Designation:LMA-463						
Repair Type: Erosion						
Rating:Area of Concern						
Field Date:8/16/2017						
Notes:

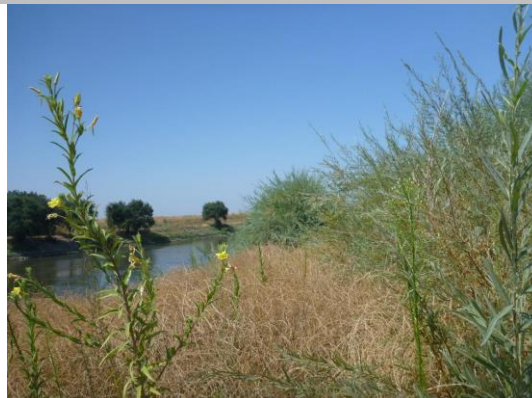
Photo 3 of 3 : LEVAL\_FA\_2018\_556\_4522.jpg

LM Start	0.21	Rating **	A/W	Issue No.	37 (cont)
LM End	0.23	Issue Type +	Ma	Location *	
Category	Supplemental			GPS Latitude/Longitude	
				Start	End
Item	2017 Storm Damage			37.808300 °	37.808400 °
				-121.332000 °	-121.332200 °
DWR ID	DWR_RD0544_02_f _ 2017_37				
Comment Code					
Inspector Comment					
Levee Evaluation Comments					
Description:Slope protection repairs are needed along the waterside slope due to erosion and riprap displacement from high water. Based upon levee inspections, it was determined the waterside levee slope is eroding, deteriorating, and degrading. The eroded levee sections need to be restored back to design standards to prevent further deterioration and damage.					
Site ID No:556					
Site Designation:LMA-462					
Repair Type: Erosion					
Rating:Area of Concern					
Field Date:8/16/2017					
Notes:

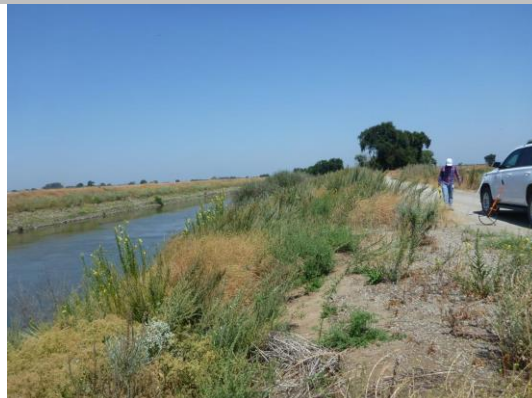
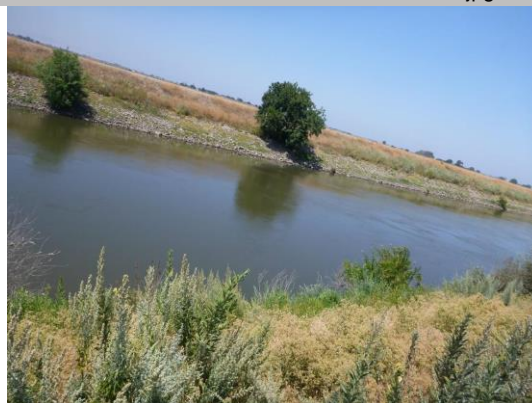
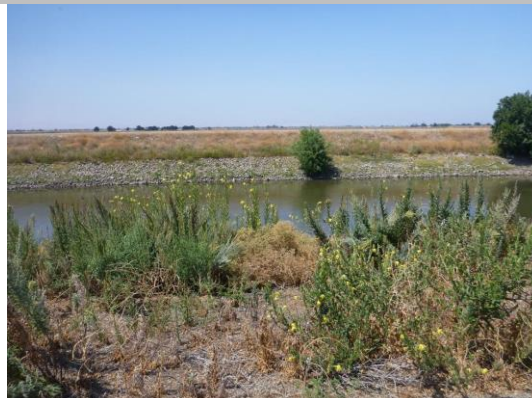
LM Start	0.44	Rating **	A/W	Issue No.	70
LM End	0.46	Issue Type +	Ma	Location *	
Category	Supplemental			GPS Latitude/Longitude	
				Start	End
Item	2017 Storm Damage			37.810400 °	37.810700 °
				-121.335000 °	-121.335000 °
DWR ID	DWR_RD0544_02_f_2017_70				
Comment Code					
Inspector Comment					
Levee Evaluation Comments					
Description:Slope protection repairs are needed along the waterside slope due to erosion and riprap displacement from high water. Based upon levee inspections, it was determined the waterside levee slope is eroding, deteriorating, and degrading. The eroded levee sections need to be restored back to design standards to prevent further deterioration and damage.					
Site ID No:555					
Site Designation:LMA-461					
Repair Type: Erosion					
Rating:Area of Concern					
Field Date:8/16/2017					
Notes:

LM Start	<b>0.44</b>	Rating **	A/W	Issue No.	<b>70 (cont)</b>
LM End	<b>0.46</b>	Issue Type +	Ma	Location *	
Category	Supplemental			GPS Latitude/Longitude	
				Start	End
Item	2017 Storm Damage			37.810400°	37.810700°
				-121.335000°	-121.335000°
DWR ID	DWR_RD0544_02_f_2017_70				
Comment Code					
Inspector Comment					
<p>Levee Evaluation Comments</p> <p>Description: Slope protection repairs are needed along the waterside slope due to erosion and riprap displacement from high water. Based upon levee inspections, it was determined the waterside levee slope is eroding, deteriorating, and degrading. The eroded levee sections need to be restored back to design standards to prevent further deterioration and damage.</p> <p>Site ID No: 555</p> <p>Site Designation: LMA-461</p> <p>Repair Type: Erosion</p> <p>Rating: Area of Concern</p> <p>Field Date: 8/16/2017</p> <p>Notes:</p>

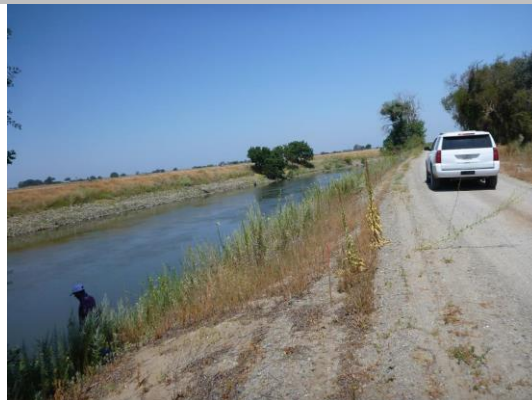
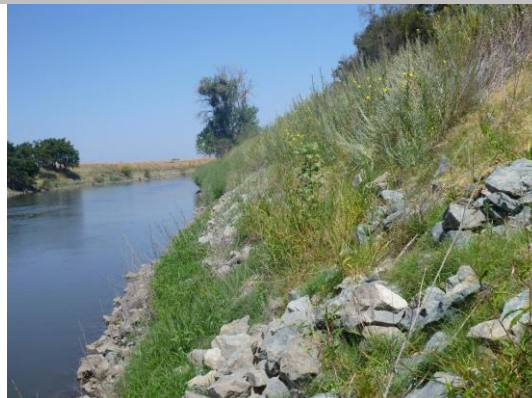
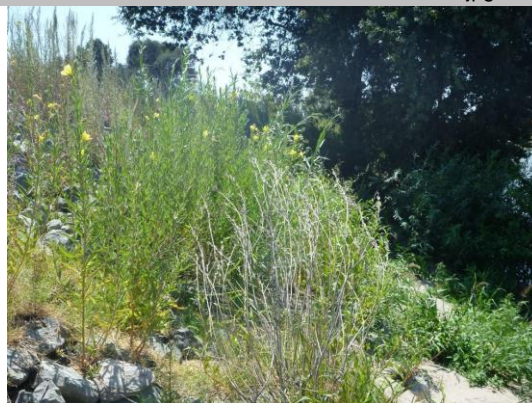
LM Start	<b>0.57</b>	Rating **	A/W	Issue No.	<b>80</b>
LM End	<b>0.58</b>	Issue Type +	Ma	Location *	
Category	Supplemental			GPS Latitude/Longitude	
				Start	End
Item	2017 Storm Damage			37.812300°	37.812400°
				-121.335100°	-121.335100°
DWR ID	DWR_RD0544_02_f_2017_80				
Comment Code					
Inspector Comment					
<p>Levee Evaluation Comments</p> <p>Description: Slope protection repairs are needed along the waterside slope due to erosion and riprap displacement from high water. Based upon levee inspections, it was determined the waterside levee slope is eroding, deteriorating, and degrading. The eroded levee sections need to be restored back to design standards to prevent further deterioration and damage.</p> <p>Site ID No: 554</p> <p>Site Designation: LMA-460</p> <p>Repair Type: Erosion</p> <p>Rating: Area of Concern</p> <p>Field Date: 8/16/2017</p> <p>Notes:</p>

LM Start	0.57	Rating **	A/W	Issue No.	80 (cont)
LM End	0.58	Issue Type +	Ma	Location *	
Category	Supplemental			GPS Latitude/Longitude	
				Start	End
Item	2017 Storm Damage			37.812300 °	37.812400 °
				-121.335100 °	-121.335100 °
DWR ID	DWR_RD0544_02_f_2017_80				
Comment Code					
Inspector Comment					
Levee Evaluation Comments					
Description:Slope protection repairs are needed along the waterside slope due to erosion and riprap displacement from high water. Based upon levee inspections, it was determined the waterside levee slope is eroding, deteriorating, and degrading. The eroded levee sections need to be restored back to design standards to prevent further deterioration and damage.					
Site ID No:554					
Site Designation:LMA-460					
Repair Type: Erosion					
Rating:Area of Concern					
Field Date:8/16/2017					
Notes:

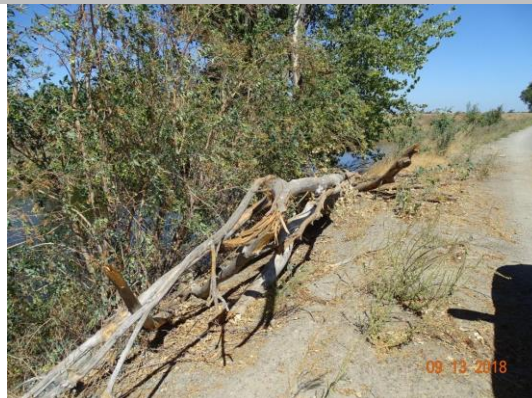
Photo 1 of 2 : FA\_2018\_RD0544\_109\_27\_20180919\_00125.jpg

LM Start	0.64	Rating **	U	Issue No.	27
LM End	0.64	Issue Type +	Ma	Location *	WS
Category	Earthen Levee			GPS Latitude/Longitude	
				Start	End
Item	Encroachments			37.813307°	37.813307°
				-121.335135°	-121.335135°
DWR ID	DWR_RD0544_02_f_2018_27				
Comment Code					
TR : Tree or limb					
Inspector Comment

Looking southeast at tree limbs on waterward shoulder. (Fall 2018)

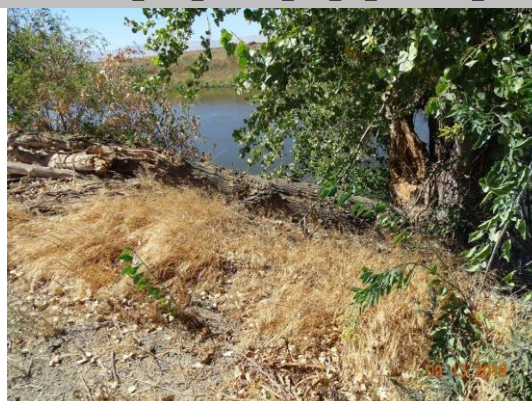
Photo 2 of 2 : FA\_2018\_RD0544\_109\_27\_20180919\_00126.jpg

Looking east at tree trunk on waterslope slope. (Fall 2018)

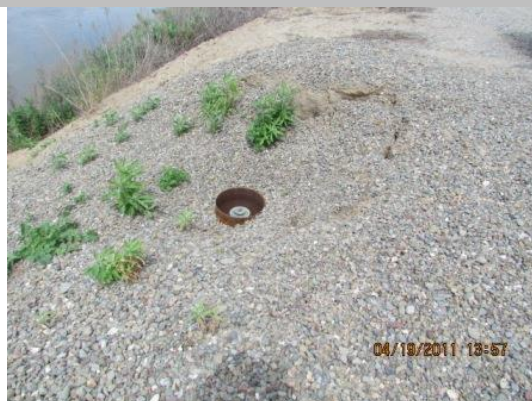
Photo 1 of 4 : FA\_2018\_RD0544\_109\_8\_20180906\_00006.jpg

Looking south at depression greater than 6" on waterside shoulder.

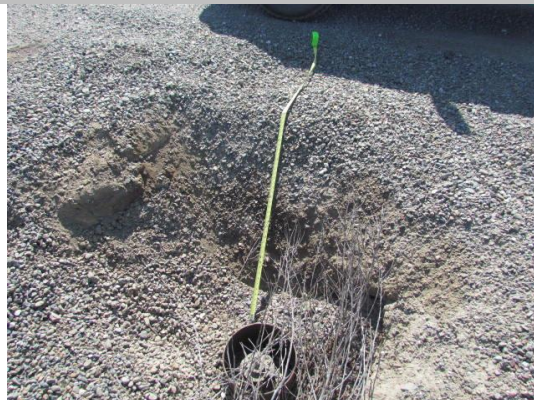
Photo 3 of 4 : FA\_2018\_RD0544\_109\_8\_20180906\_00008.jpg

Looking west at caving around siphon on waterside shoulder. (Spring 2012)

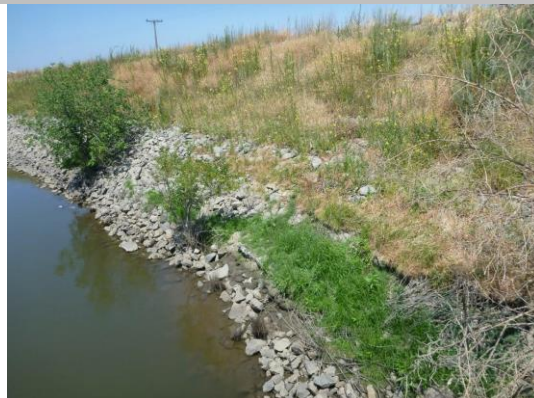
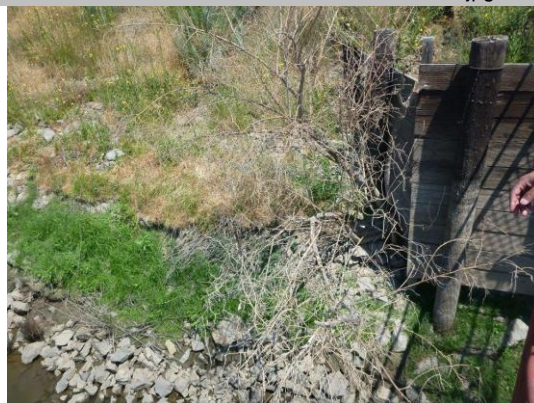
LM Start	1.01	Rating **	A/W	Issue No.	82
LM End	1.02	Issue Type +	Ma	Location *	
Category	Supplemental			GPS Latitude/Longitude	
				Start	End
Item	2017 Storm Damage			37.818100 °	37.818200 °
				-121.332800 °	-121.332800 °
DWR ID	DWR_RD0544_02_f_2017_82				
Comment Code					
Inspector Comment					
Levee Evaluation Comments					
Description:Slope protection repairs are needed along the waterside slope due to erosion and riprap displacement from high water. Based upon levee inspections, it was determined the waterside levee slope is eroding, deteriorating, and degrading. The eroded levee sections need to be restored back to design standards to prevent further deterioration and damage.					
Site ID No:552					
Site Designation:LMA-458					
Repair Type: Erosion					
Rating:Area of Concern					
Field Date:8/16/2017					
Notes:

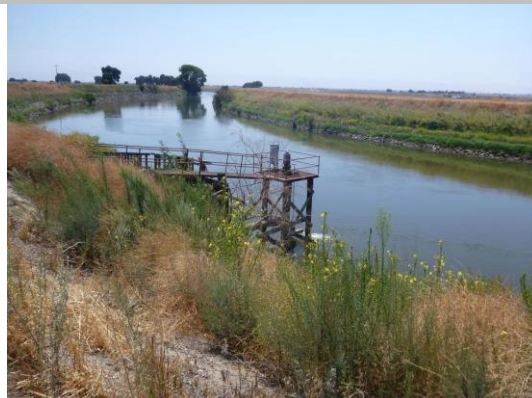
Photo 3 of 3 : LEVAL\_FA\_2018\_552\_4813.jpg

LM Start	1.01	Rating **	A/W	Issue No.	82 (cont)	
LM End	1.02	Issue Type +	Ma	Location *		
Category	Supplemental			GPS Latitude/Longitude		
				Start	End	
Item	2017 Storm Damage			37.818100 °	37.818200 °	
				-121.332800 °	-121.332800 °	
DWR ID	DWR_RD0544_02_f_2017_82					
Comment Code						
Inspector Comment						
Levee Evaluation Comments						
Description:Slope protection repairs are needed along the waterside slope due to erosion and riprap displacement from high water. Based upon levee inspections, it was determined the waterside levee slope is eroding, deteriorating, and degrading. The eroded levee sections need to be restored back to design standards to prevent further deterioration and damage.						
Site ID No:552						
Site Designation:LMA-458						
Repair Type: Erosion						
Rating:Area of Concern						
Field Date:8/16/2017						
Notes:

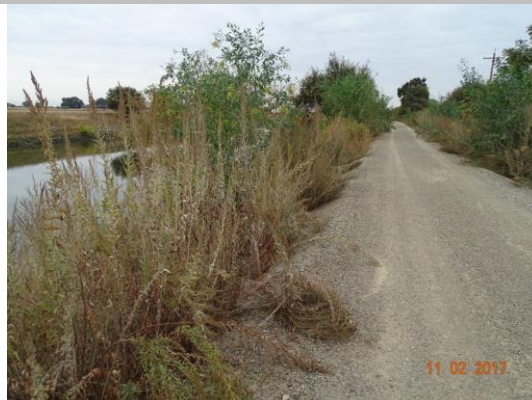
Photo 1 of 1 : FA\_2018\_RD0544\_109\_101\_20180906\_00093.jpg

LM Start	1.29	Rating **	U	Issue No.	101
LM End	1.56	Issue Type +	Ma	Location *	WS
Category	Earthen Levee			GPS Latitude/Longitude	
				Start	End
Item	Vegetation			37.820668 °	37.822239 °
				-121.336491 °	-121.340589 °
DWR ID	DWR_RD0544_02_f_2017_101				
Comment Code					
V2 : Remove the wild growth other than native grasses from the levee slopes.					
Inspector Comment

Looking northwest at the waterside slope.

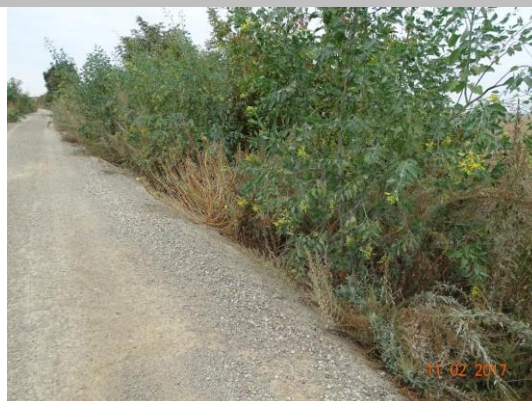
Photo 1 of 1 : FA\_2018\_RD0544\_109\_102\_20180906\_00094.jpg

LM Start	1.29	Rating **	U	Issue No.	102
LM End	1.56	Issue Type +	Ma	Location *	LS
Category	Earthen Levee			GPS Latitude/Longitude	
				Start	End
Item	Vegetation			37.820668 °	37.822239 °
				-121.336491 °	-121.340589 °
DWR ID	DWR_RD0544_02_f_2017_102				
Comment Code					
V2 : Remove the wild growth other than native grasses from the levee slopes.					
Inspector Comment

Looking northwest at the landside slope.

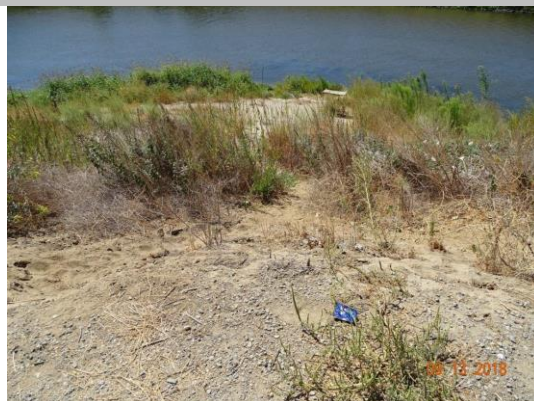
Photo 2 of 2 : FA\_2018\_RD0544\_109\_34\_20180919\_00131.jpg

LM Start	1.91	Rating **	M	Issue No.	34
LM End	1.91	Issue Type +	Ma	Location *	WS
Category	Earthen Levee			GPS Latitude/Longitude	
				Start	End
Item	Erosion / Bank Caving			37.817658 °	37.817658 °
				-121.342097 °	-121.342097 °
DWR ID	DWR_RD0544_02_f_2018_34				
Comment Code					
E1 : Note and monitor erosion site.					
Inspector Comment					
Erosion cause by foot traffic

Looking east at foot erosion on waterward slope. (Fall 2018)

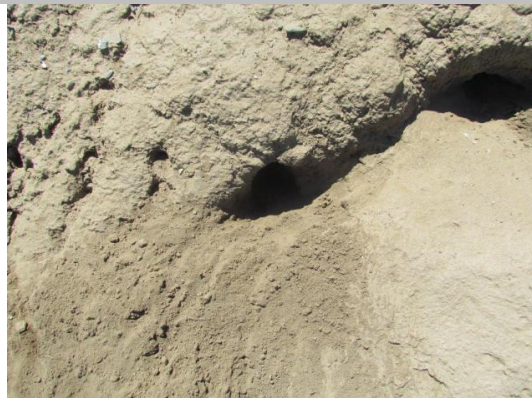
Photo 1 of 1 : FA\_2018\_RD0544\_109\_58\_20180906\_00040.jpg

LM Start	2.02	Rating **	U	Issue No.	58
LM End	2.09	Issue Type +	Ma	Location *	LS
Category	Earthen Levee			GPS Latitude/Longitude	
				Start	End
Item	Animal Control			37.818853 °	37.819493 °
				-121.343473 °	-121.344545 °
DWR ID	DWR_RD0544_02_s_2015_58				
Comment Code					
A1 : Exterminate rodents and backfill and compact or grout burrows.					
Inspector Comment					
Several rodent holes within reach on landside slope.

Looking at typical rodent holes on landward slope.

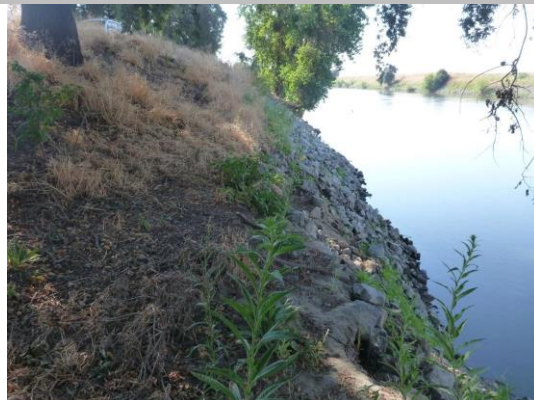
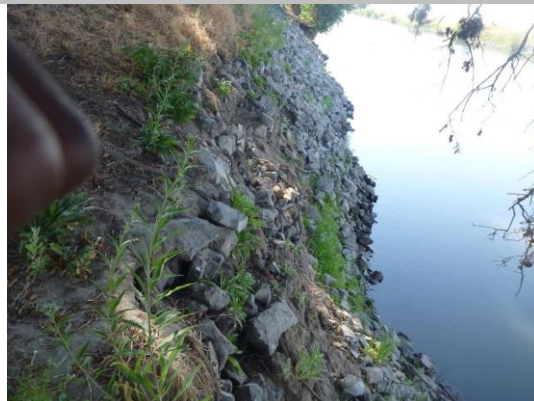
Description: Slope protection repairs are needed along the waterside slope due to erosion and riprap displacement from high water. Based upon levee inspections, it was determined the waterside levee slope is eroding, deteriorating, and degrading. The eroded levee sections need to be restored back to design standards to prevent further deterioration and damage.

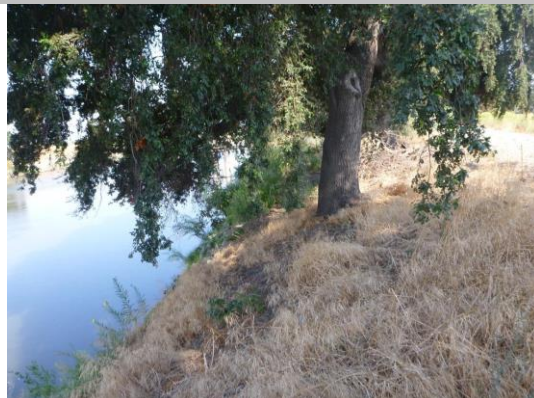
Photo 3 of 3 : LEVAL\_FA\_2018\_551\_4824.jpg

LM Start	<b>2.17</b>	Rating **	A/W	Issue No.	<b>87 (cont)</b>
LM End	<b>2.18</b>	Issue Type +	Ma	Location *	
Category	Supplemental			GPS Latitude/Longitude	
				Start	End
Item	2017 Storm Damage			37.820300°	37.820300°
				-121.345600°	-121.345700°
DWR ID	DWR_RD0544_02_f_2017_87				
Comment Code					
Inspector Comment					
<p>Levee Evaluation Comments</p> <p>Description: Slope protection repairs are needed along the waterside slope due to erosion and riprap displacement from high water. Based upon levee inspections, it was determined the waterside levee slope is eroding, deteriorating, and degrading. The eroded levee sections need to be restored back to design standards to prevent further deterioration and damage.</p> <p>Site ID No: 551</p> <p>Site Designation: LMA-457</p> <p>Repair Type: Erosion</p> <p>Rating: Serious</p> <p>Field Date: 8/18/2017</p> <p>Notes:</p>

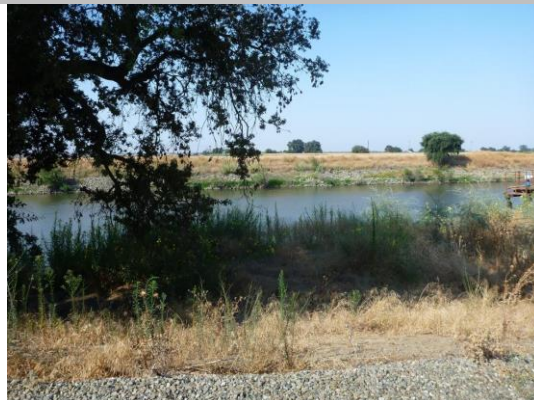
Photo 1 of 4 : LEVAL\_FA\_2018\_550\_4832.jpg

LM Start	<b>2.18</b>	Rating **	A/W	Issue No.	<b>88</b>
LM End	<b>2.19</b>	Issue Type +	Ma	Location *	
Category	Supplemental			GPS Latitude/Longitude	
				Start	End
Item	2017 Storm Damage			37.820400°	37.820500°
				-121.345800°	-121.345900°
DWR ID	DWR_RD0544_02_f_2017_88				
Comment Code					
Inspector Comment					
<p>Levee Evaluation Comments</p> <p>Description: Slope protection repairs are needed along the waterside slope due to erosion and riprap displacement from high water. Based upon levee inspections, it was determined the waterside levee slope is eroding, deteriorating, and degrading. The eroded levee sections need to be restored back to design standards to prevent further deterioration and damage.</p> <p>Site ID No: 550</p> <p>Site Designation: LMA-456</p> <p>Repair Type: Erosion</p> <p>Rating: Area of Concern</p> <p>Field Date: 8/18/2017</p> <p>Notes:</p>

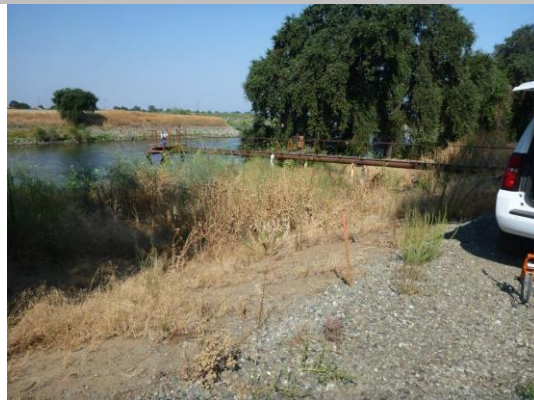
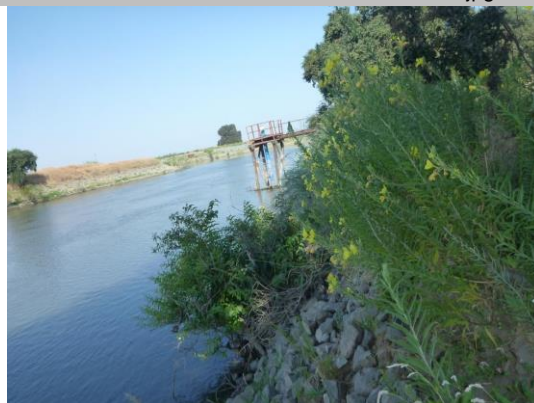
LM Start	<b>2.18</b>	Rating **	A/W	Issue No.	<b>88 (cont)</b>					
LM End	<b>2.19</b>	Issue Type +	Ma	Location *						
Category	Supplemental		GPS Latitude/Longitude							
			Start	End						
Item	2017 Storm Damage		37.820400°	37.820500°						
			-121.345800°	-121.345900°						
DWR ID	DWR_RD0544_02_f_2017_88									
Comment Code										
Inspector Comment										
Levee Evaluation Comments Description: Slope protection repairs are needed along the waterside slope due to erosion and riprap displacement from high water. Based upon levee inspections, it was determined the waterside levee slope is eroding, deteriorating, and degrading. The eroded levee sections need to be restored back to design standards to prevent further deterioration and damage. Site ID No: 550 Site Designation: LMA-456 Repair Type: Erosion Rating: Area of Concern Field Date: 8/18/2017 Notes:
